AFML-TR-67-293

INVESTIGATION OF MAGNITUDE AND DISTRIBUTION OF STRESSES
IN WELDED STRUCTURES

North American Aviation, Inc., Los Angeles Division

September 1967

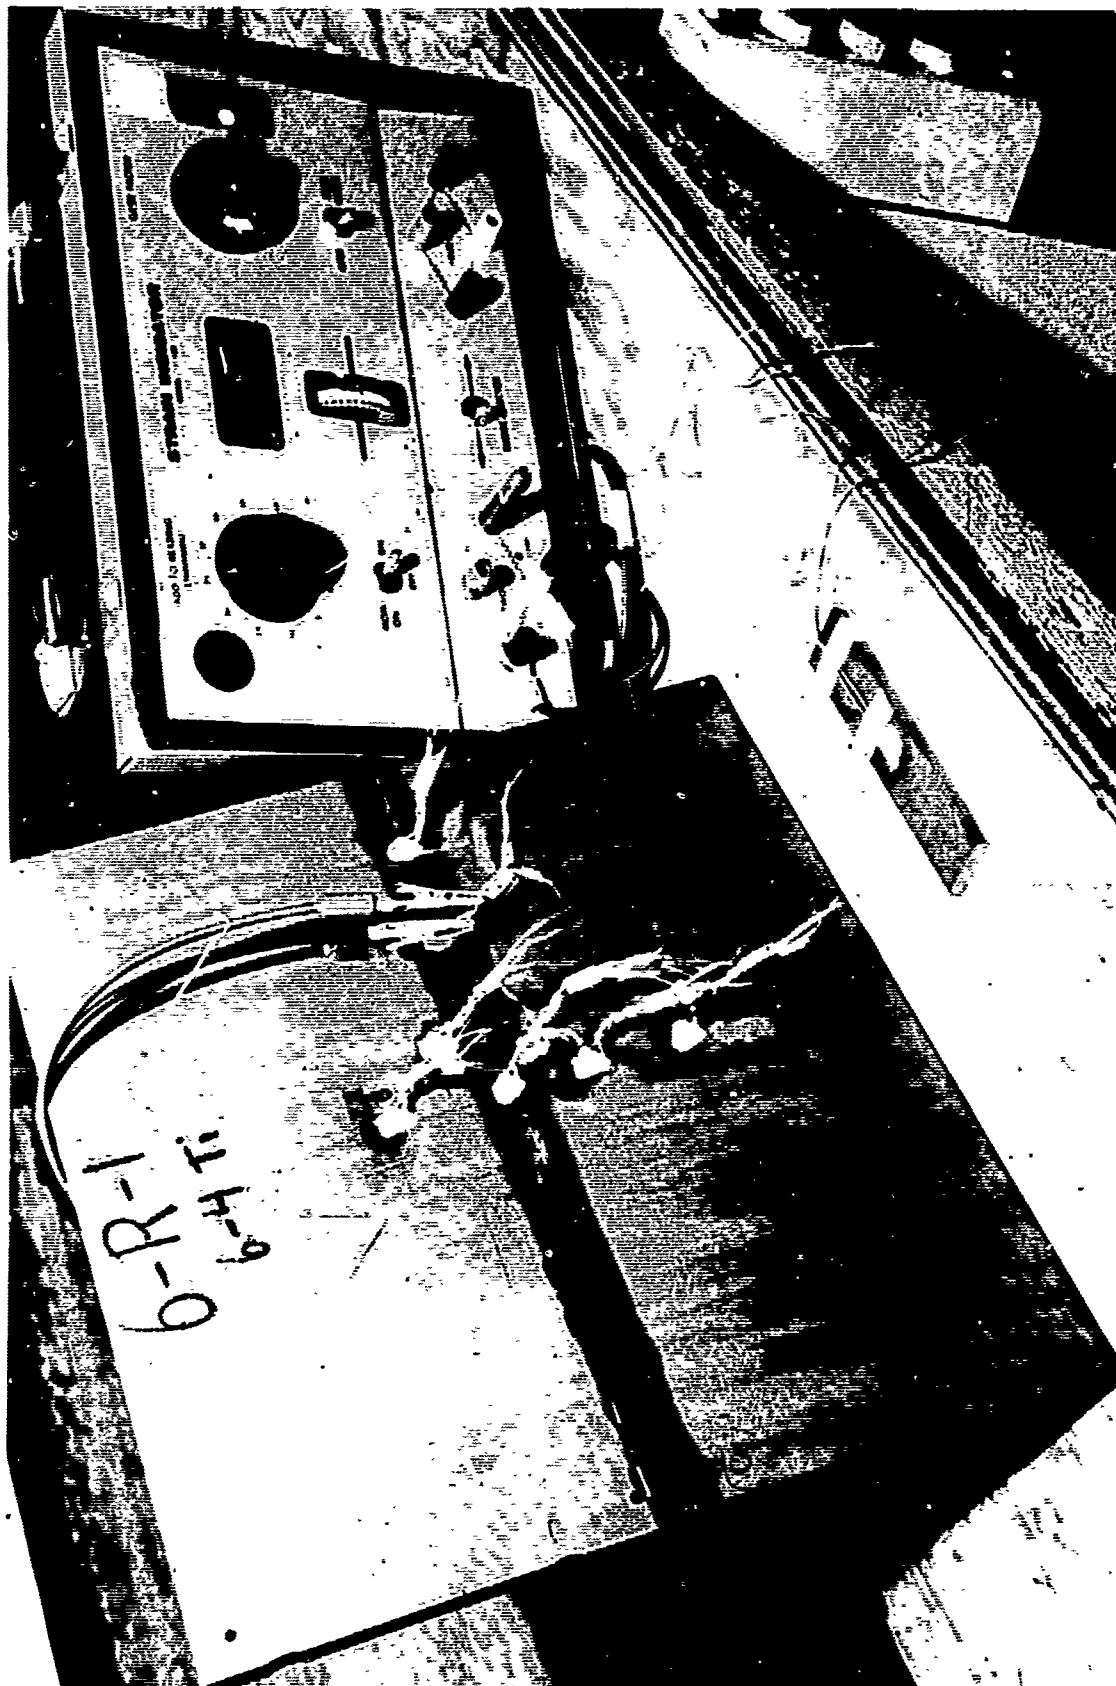
Figure 4. Strain Gage Instrumentation on 0.200-Inch Ti-6Al-4V Panel

overall dimensions of 0.114 by 0.062 inch were used. Figure 4 shows a Ti-6Al-4V alloy plate with the mounted strain gage: the dummy gage used for reference, and the Baldwin-Lima-Hamilton Model 120 Digital Strain Indicator.

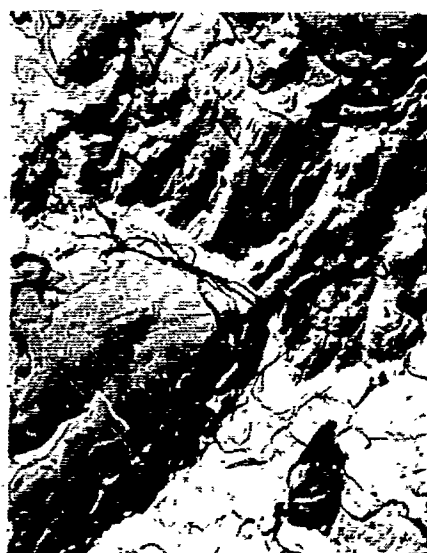
Figure 28. Electron Fractographs of Stress Relieved
Ti-6Al-4V Fracture Toughness Specimen (2500X)

A - FATIGUE CRACK AREA

B - PLANE STRAIN ZONE

C - MIXED MODE FRACTURE IN WELD

D - SHEAR LIP AREA

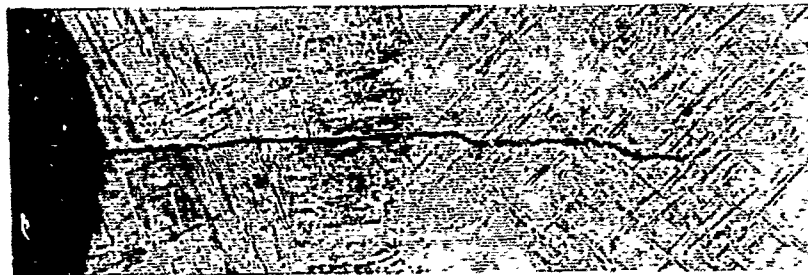
Figure 45. Fractured Faces Precracked Ti-6Al-4V Charpy Specimens, Mag. 2X

As Welded

Stress Relieved at 1000°F for 3 Hours
Followed by Air Cooling

Stress Relieved at 1450°F for 15 Minutes
Followed by Air Cooling

Visual examination was made on the fracture surface of the Charpy specimens shown in figures 45 through 47. It was found that Ti-5Al-2.5Sn generally exhibits shear type of fracture, whereas Ti-6Al-4V and Ti-8Al-1Mo-1V show evidence of cleavage. This observation seems to be in agreement with the magnitudes of W/A determined for each alloy. Also the degree of flat fracture appears to be more pronounced in the 1000°F stress-relieved and 1450°F stress-relieved specimens than in the as-welded specimens, indicating greater toughness in the latter as was shown by the slow bend fracture toughness data. The difference in fracture surface appearance among the Ti-5Al-2.5Sn specimens was not readily apparent.

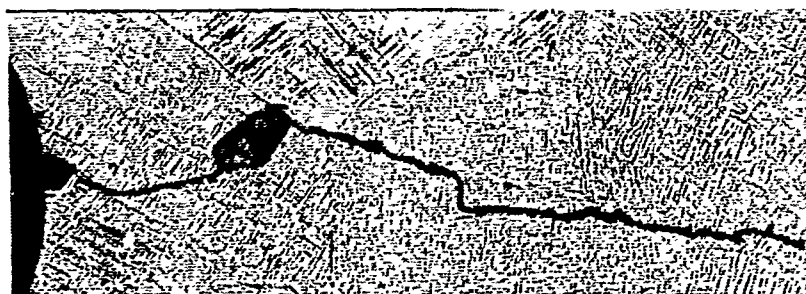
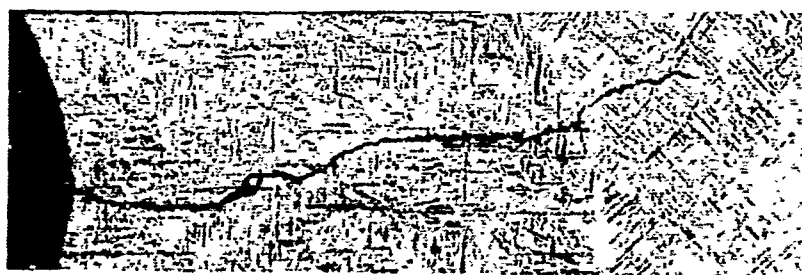
Figure 42. Precracked Ti-6Al-4V Charpy Specimens, Mag. 150X

Stress Relieved at 1000°F for 3 Hours
Followed by Air Cooling

Stress Relieved at 1450°F for 15 Minutes
Followed by Air Cooling

Although considerable scatter was shown in the W/A data for each condition, there was no indication that this variation could be attributed to the variations in precracked depth. Photomicrographs of the cross section of the precracked area are shown in figures 42 through 44. Fatigue cracks traverse the acicular structure transgranularly across a prior beta grain. The direction of cracking does not appear to follow any pattern or orientation in the microstructure. Examination of the weld and the unaffected base metal failed to reveal any microstructural differences between the as-welded, 1000°F stress-relieve, and 1450°F stress-relieve conditions which could be a clue to explain the difference in fracture toughness behavior.

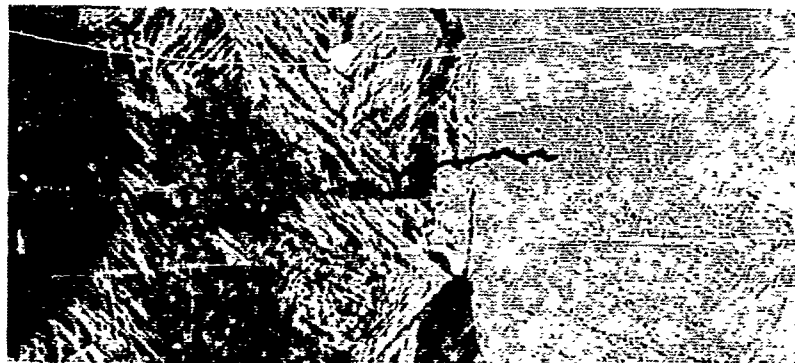
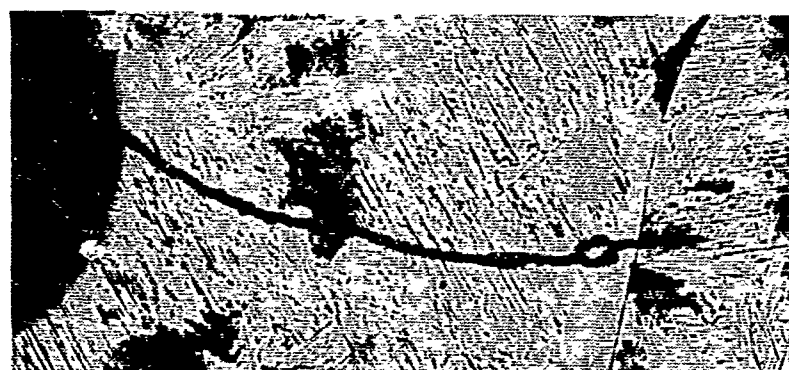
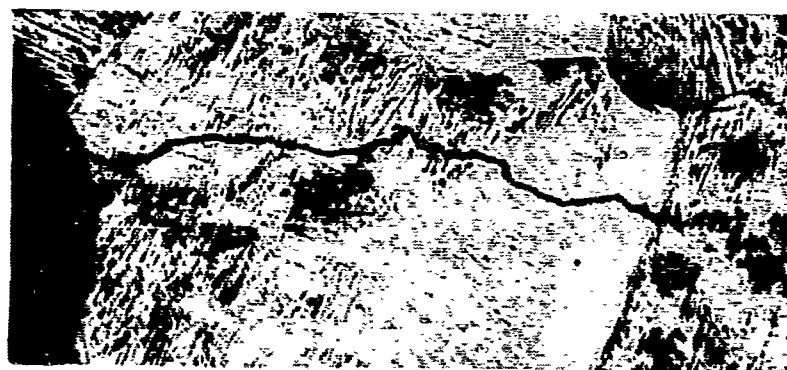
Figure 44. Precracked Ti-5Al-2.5Sn Charpy Specimens, Mag. 150X

As Welded

Stress Relieved at 1000°F for 3 Hours
Followed by Air Cooling

Stress Relieved at 1450°F for 15 Minutes
Followed by Air Cooling
